**RIVER ROUGE OIL SPILL, DEARBORN, MICHIGAN
APRIL 2002
SITE INSPECTION REPORT FOR
SYBILL, INC.
DETROIT, WAYNE COUNTY, MICHIGAN**

Date Prepared	27 August 2002
TDD Number	S05-0204-010
Document Control Number	252-2A-ACBJ
Contract Number	68-W-00-119
START Program Manager	John W. Thorsen, P.E.
Telephone No.	(847) 918-4102
U.S. EPA On-Scene Coordinator	Ralph Dollhopf

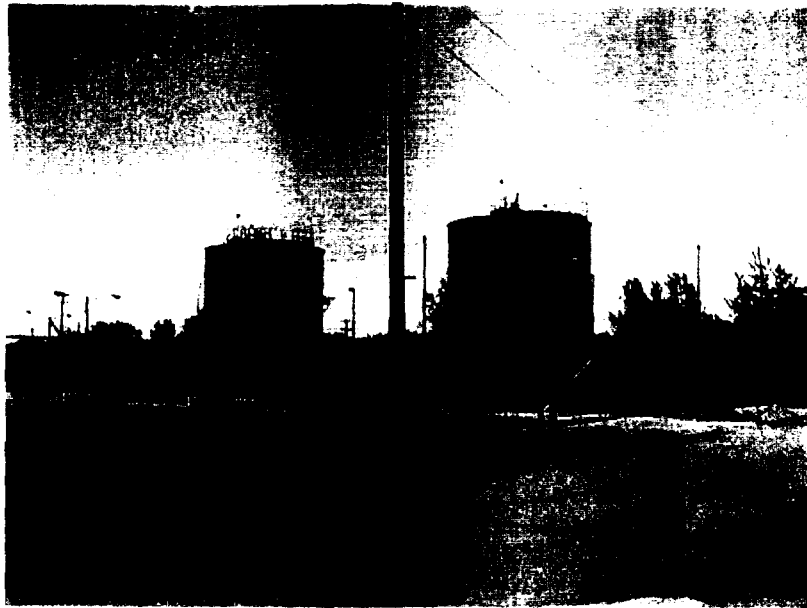
PHOTO NO: 4

Two 250,000-gallon ASTs (Nos. 1 and 2) were located in the parking area to the northeast of the facility across Military Road (Attachment C, Photo 4). These ASTs are within a concrete secondary containment with a concrete floor. The secondary containment for AST Nos. 1 and 2 held approximately 3 inches of oily water and sludge (Attachment C, Photos 9 and 36). AST No. 1, the northernmost tank, was mostly empty; however, it did contain approximately 6 feet of sludge and 6 inches of oily material. A sample (ROS-CG-152) of what appeared to be a thick, dark gray to black, sludgy oil mixture was collected.

SUBJECT: A view of 250,000-gallon ASTs adjacent to the roadway.

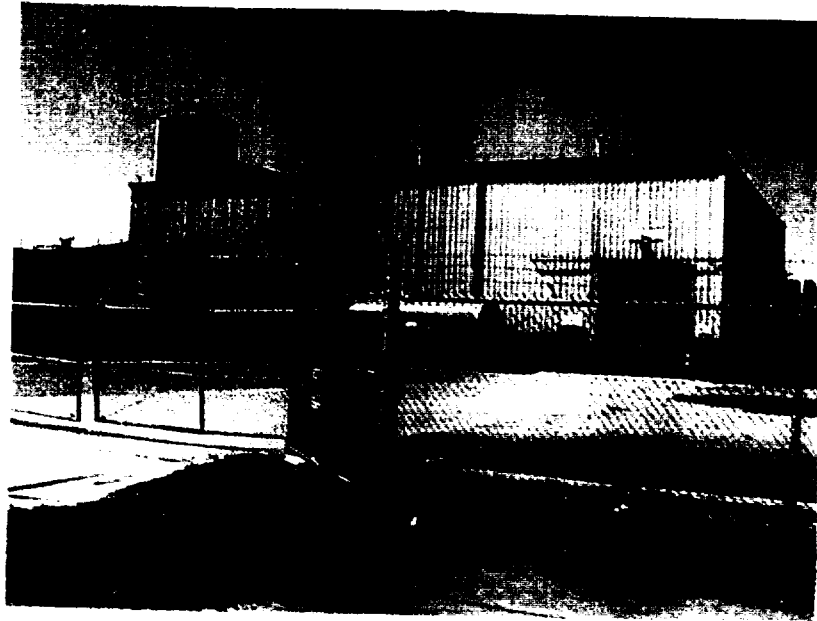
PHOTO NO: 6

SUBJECT: A view of the processing building.

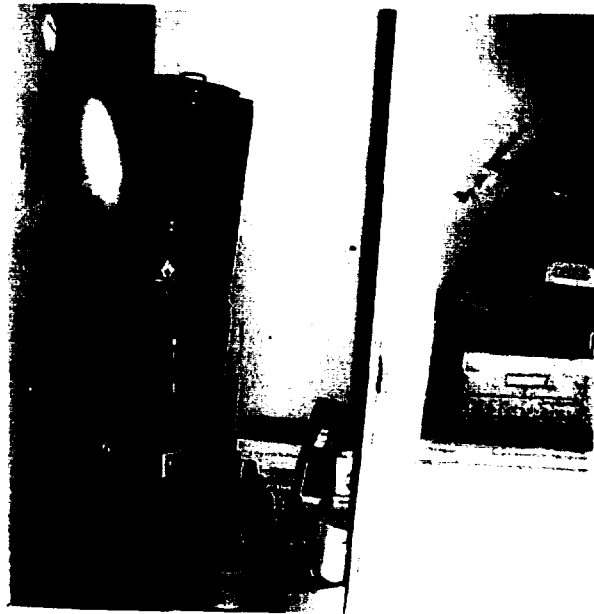
PHOTO NO: 49

The second floor of the office building was comprised of an abandoned lab, office space, chemical and sample storage and two ASTs. Some of the material stored in the office area was labeled as polychlorinated biphenyls (PCBs) and flammable (Attachment C, Photos 49 and 81). No samples were collected from this building.

SUBJECT: A view of material stored in the office building.

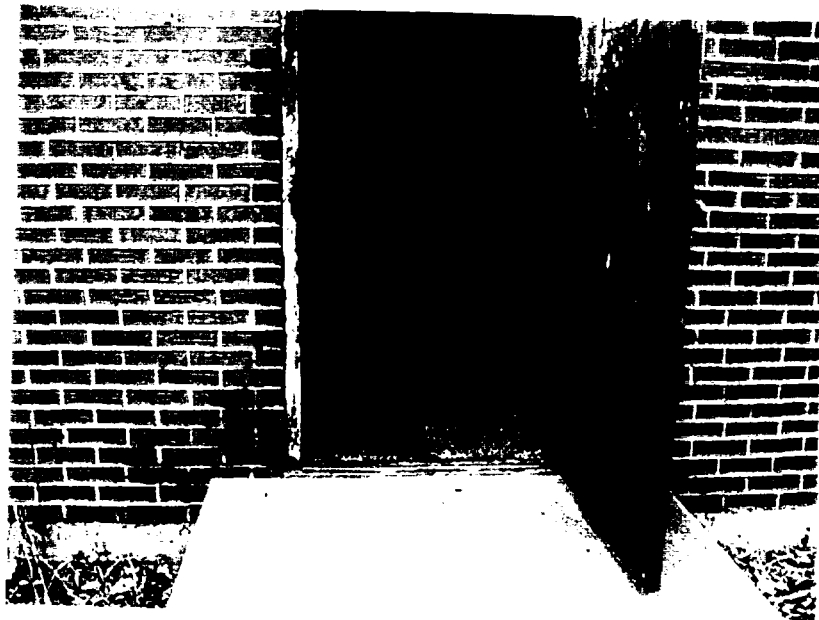
PHOTO NO: 53

SUBJECT: A view of the pump house at the northern section of the facility, adjacent to AST Nos. 1 and 2.

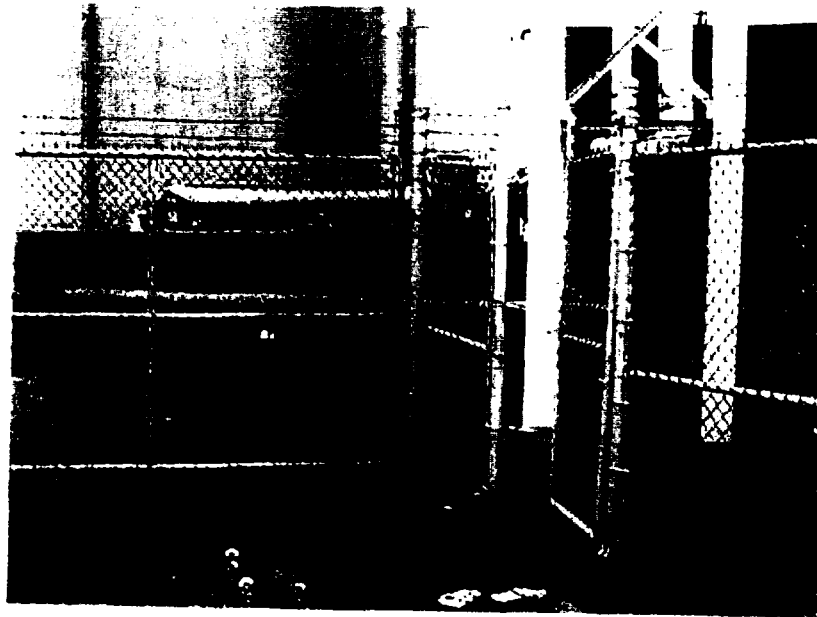
PHOTO NO: 58

SUBJECT: A view of an unsecured gate adjacent to the pump house.

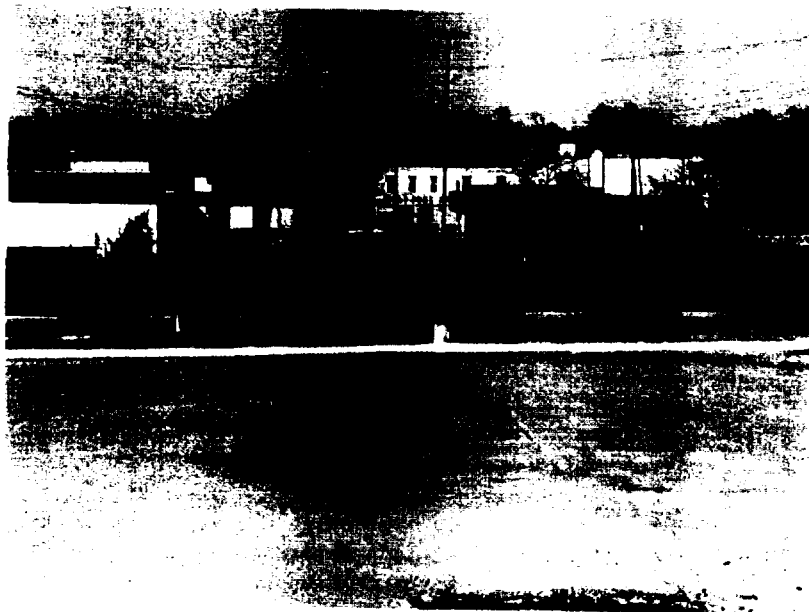
PHOTO NO: 66

SUBJECT: A view of the tanker trailer spill pad.

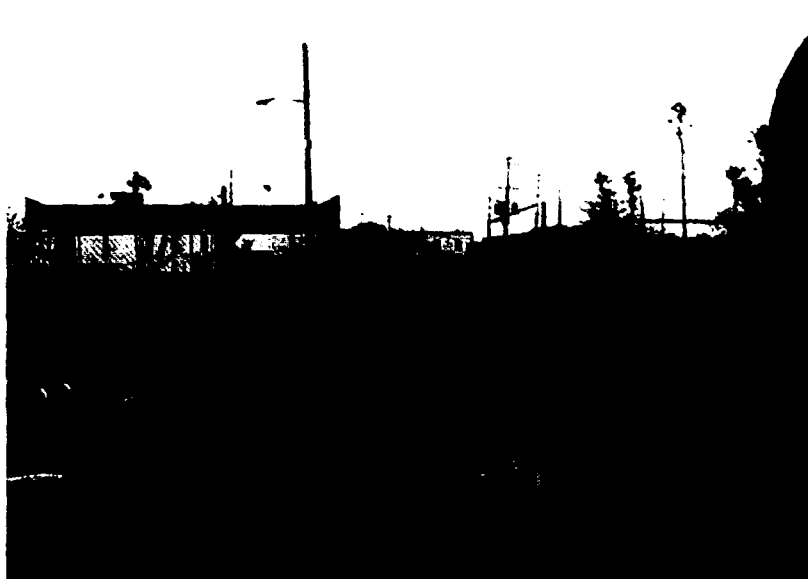
PHOTO NO: 68

SUBJECT: A view of an unsecured gated entrance to the southern portion of the property.

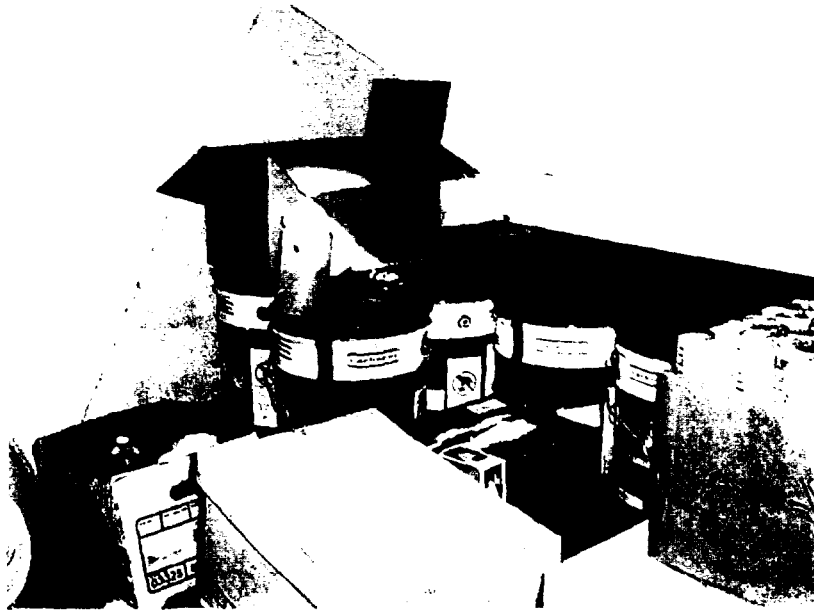
PHOTO NO: 81

SUBJECT: A view of various unsecured supplies located in the office building.
